MII – Power Generation

'War Stories'

20 June 2023

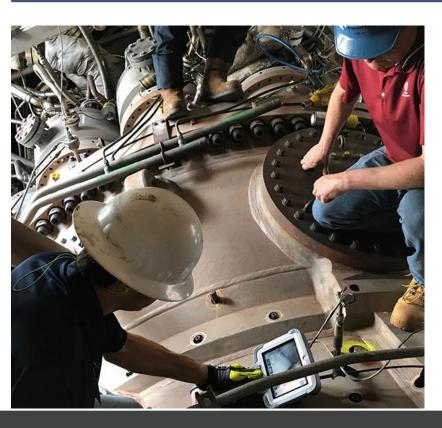
Power Plant – Machinery Breakdown

- Breakdown event during normal operations
- High-Pressure Compressor (HPC) section confirmed to have impact damage
- LM6000 cannot be repaired on site, or even opened up for detailed damage inspection
- No LTSA in place, no access to lease or spare engine
- All loss mitigation and expediting solutions under consideration
- Decision on remedial option needed to be made in advance of RCA completion
